Case Study #13

**Case Study 13 - Objective: Clean slag
build-up from Coreless Induction
furnace walls and extend lining life**

**Field Trial of REDUX EF40L in a 1.5 Metric Ton
Coreless Induction Furnace at
International Foundry "M" pouring Grey and Ductile Iron**

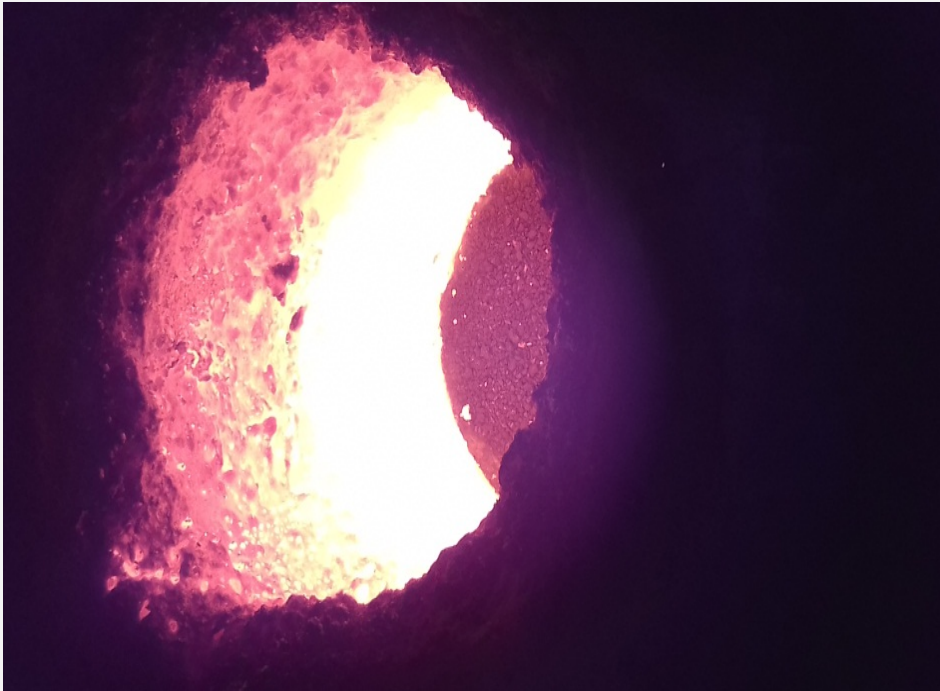
Lining condition
before trial

- Dirty, un-shot blasted foundry returns generate considerable slag build-up on refractory lining
- High temperature (1500°C/2732°F) is required to clean slag from furnace walls
- Due to slaggy lining conditions, CAP voltage signal is continuously on

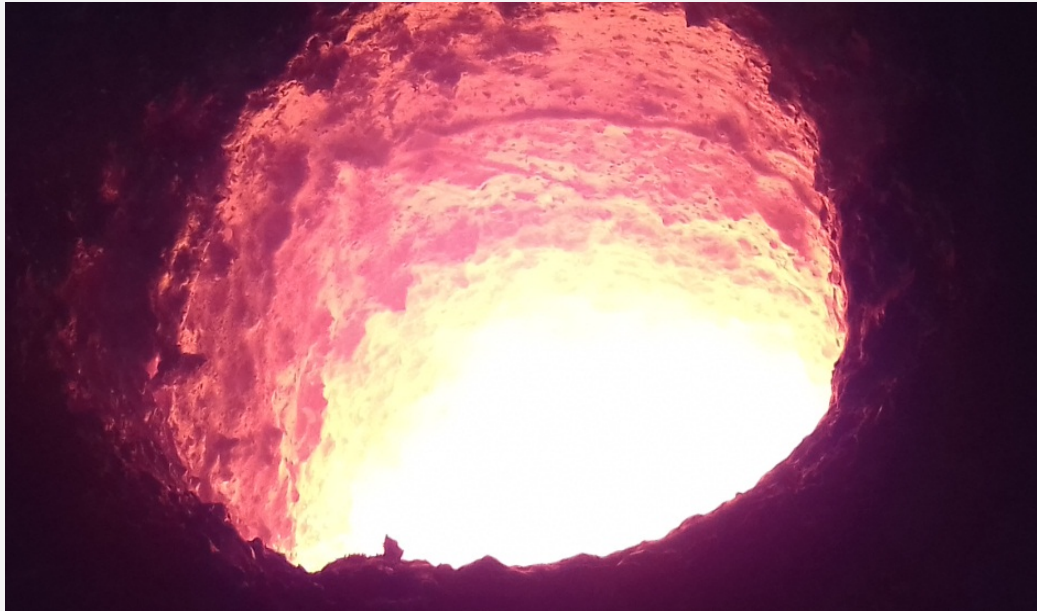
Lining condition
after 1st Redux
furnace addition

- Liquid slag was generated at the top of the furnace lining
- No extra temperature was required for slag removal.
- During first 20 minutes of power on, the CAP voltage signal remained continuously on.
- It was observed that there was still approximately 30% slag adhering to the furnace walls

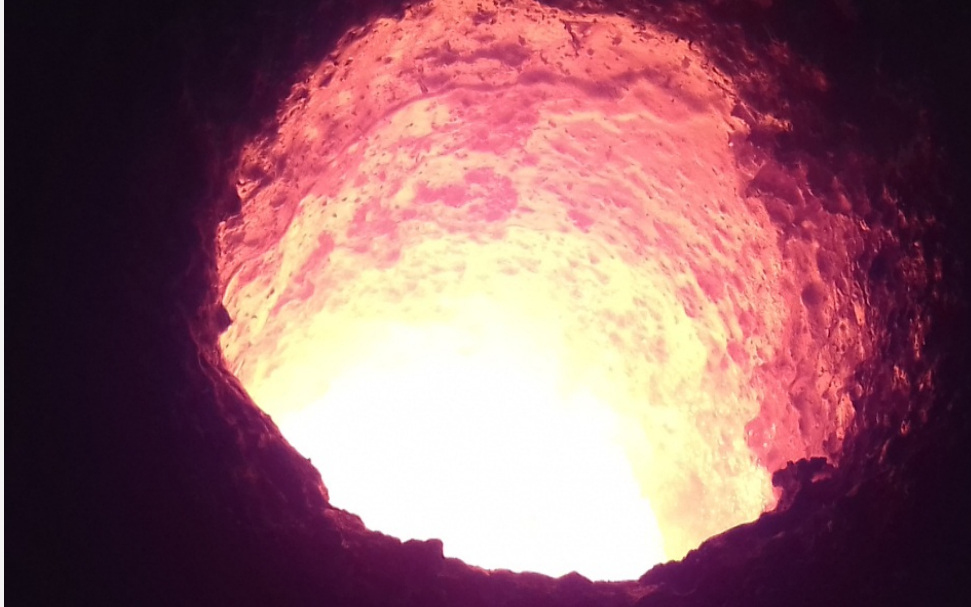
Lining condition
after 2nd Redux
addition

- The CAP voltage signal remained off during charging and melting
- All liquid slag generation remained on top of melt
- No extra time and temperature was required for melting
- Slag sticking on the furnace lining was eliminated
