Coreless Fluxing Benefits for Ferrous Foundries

David Williams, Rod Naro, ASI International

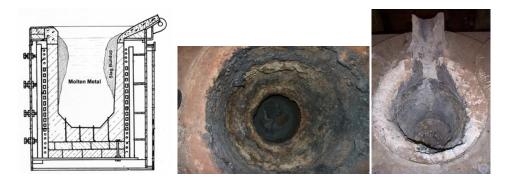
A small iron foundry that had success utilizing flux additions in a 500 pound medium frequency coreless induction furnace to combat slag build-up is shown in the accompanying example below.

This family-owned foundry had noticed unexpected "lining growth" in the 500 lb coreless induction furnace, at the rate of 25 mm (1- inch) per day. As shown above, a 2-inch thick layer of build-up occurred in 2 days of operation. There were attempts made to mechanically remove the build-up with a chipping hammer but the concern of damaging the lining prevented this to be a viable option. This became an emergency situation due to the rapid reduction of the furnace capacity and resulting loss of production.

A piece of the build-up was analyzed and found to be a combination $2MnO \cdot SiO_2$, tephroite, and $2FeO \cdot SiO_2$, fayalite. Actual build-up chemistry was found to be: 69.4% SiO₂, 11.2% FeO, 6.7% MnO, 6.6% Al₂O₃, 2.7% CaO, and 1.7% MgO. It should be noted that the FeO and MnO levels were higher than normal.

Superheating the molten metal bath at the end of the heat was attempted to remove the build-up but did not work. However, success was achieved when continuous Redux EF40_(Patent 7,618,473B1), fluoride-free flux additions to the charge (1 pound flux per ton of metal) were done. The foundry was able to reestablish the furnace capacity without any damage/wear to the domestic silica working lining.

It was later found that a recent change to a different "pig iron" coincided with the change in the sponge-like foamy black slag within the furnace. The slag change was attributed to the amount of FeO in the charge, i.e. from the condition of the pig iron. The foundry continued to use the pig iron but did modify the charge to keep the build-up manageable. This included the continuous use of flux.

Initially, the foundry could barely continue to melt through 3 days of operation. Afterwards, they returned to their normal two week production cycle. There was no longer any doubt about the effectiveness of the flux and any potential damage to the working lining.
